**Flood Control Project Maintenance  
Levee Inspections**

**Fall 2015 Levee Maintenance Deficiency Summary Report**

**Yolo County Planning Resources and Public Works**

Waterway			Bank	Unit Miles
Unit No. 01 Right Bank Cache Creek			Right	0.59
	Spring (March - May)	Summer (June - August)	(September - November) Fall	Winter (December - February)
Unit Maintenance Rating (Fall Only)			U	
Date of Inspection	04/09/2015 - 04/09/2015		09/18/2015 - 09/18/2015	
DWR Inspector	Jai Lor		Jai Lor	
Accompanied By

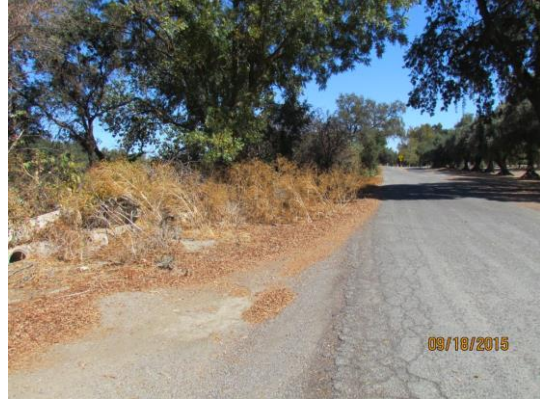
Photo 1 of 1 : FA\_2015\_NA0021\_351\_3\_20150921\_00021.jpg

LM Start	0.03	Rating **	M	Issue No.	3
LM End	0.26	Issue Type +	Ma	Location *	WS
Category	Earthen Levee			GPS Latitude/Longitude	
				Start	End
Item	Vegetation			38.720879 °	38.722424 °
				-121.810499 °	-121.806979 °
DWR ID	DWR_NA0021_01_f _ 2015_3				
Action/Comments					
Control annual grass and weeds on the levee slopes and easements.

View of the vegetation on the waterward side of the levee looking downstream. Fall 2015.

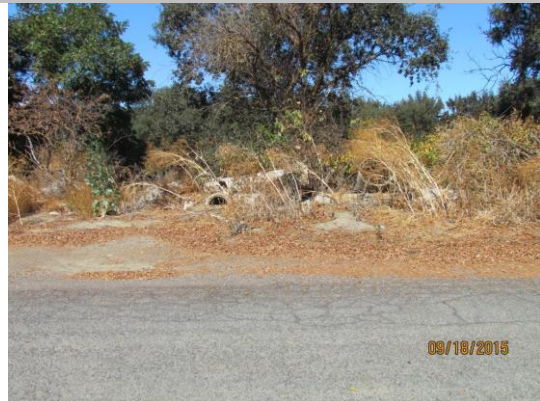
Photo 1 of 1 : FA\_2015\_NA0021\_351\_15\_20150921\_00022.jpg

LM Start	0.03	Rating **	M	Issue No.	15
LM End	0.03	Issue Type +	En	Location *	WS
Category	Earthen Levee			GPS Latitude/Longitude	
				Start	End
Item	Encroachments			38.720895 °	38.720895 °
				-121.810408 °	-121.810408 °
DWR ID	DWR_NA0021_01_f_2015_15				
Action/Comments					
Debris

View of the debris on the waterward side of the levee. Fall 2015.

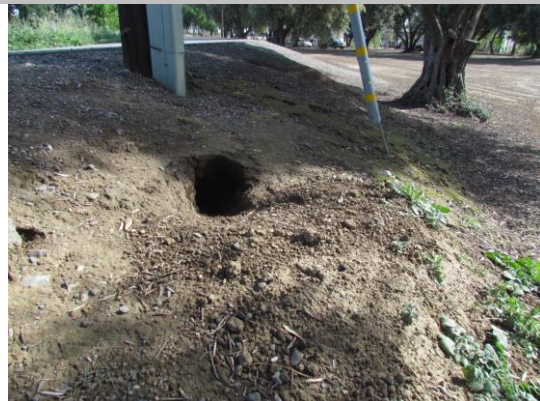
Photo 1 of 1 : FA\_2015\_NA0021\_351\_16\_20150914\_00014.jpg

LM Start	0.18	Rating **	U	Issue No.	16
LM End	0.22	Issue Type +	Ma	Location *	LS
Category	Earthen Levee			GPS Latitude/Longitude	
				Start	End
Item	Animal Control			38.721542 °	38.721918 °
				-121.807778 °	-121.807373 °
DWR ID	DWR_NA0021_01_s_2015_16				
Action/Comments					
Exterminate rodents and backfill and compact or grout burrows.

View of the rodent hole on the landward side of the levee looking downstream. Spring 2015.

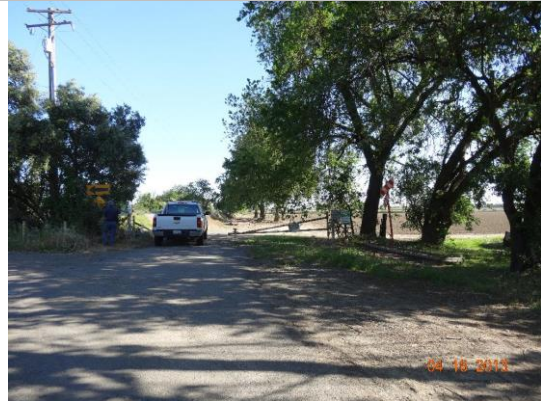
Photo 1 of 3 : UCIP\_FA\_2015\_4838.jpg

Action/Comments					
Inspector Comments: FS_ID:39855 DS_ID:19554 EP_NO: 6790 FS_HLM: 0 Repair Type: Non-Urgent Crossing Status: Indicator Found UCIP Comments: Need to contact owner to determine if crossing is still active and to determine last inspection date. Will need copy of letter showing crossings passed inspection. FIELD_STRUCT_DESC: 6-inch gas line through levee, 4-feet below the crown. Pipe extends from borrow area and under the channel. Bleeder valve on waterward bank. Service vault located on landward side next to access gate. Paved access ramp on landward slope. (Permit No. 6790-1970) FS Date: 04/16/2013

View of landward side near access gate. Gas line marker located on between trees. Line runs parallel to access roadway and through levee.

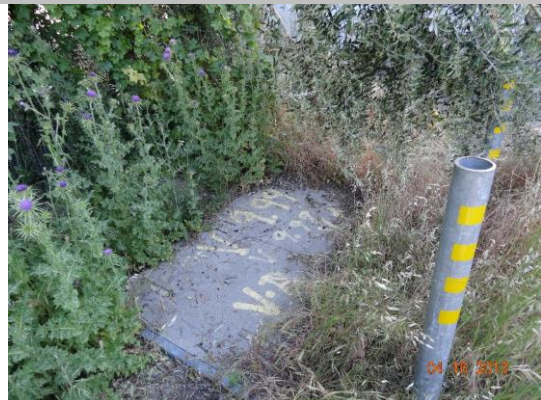
Photo 2 of 3 : UCIP\_FA\_2015\_4839.jpg

Service vault located on landward toe near gate access gate.

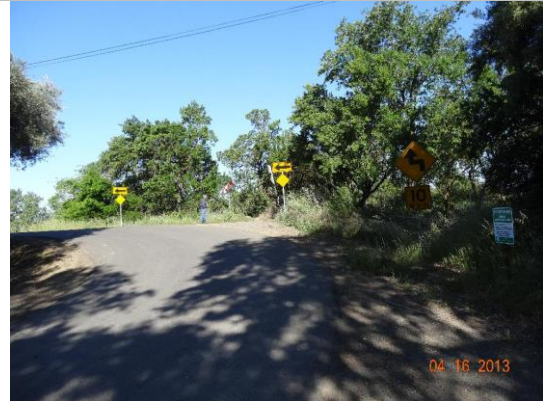
Photo 3 of 3 : UCIP\_FA\_2015\_4840.jpg

View of gas line marker located on levee crown.

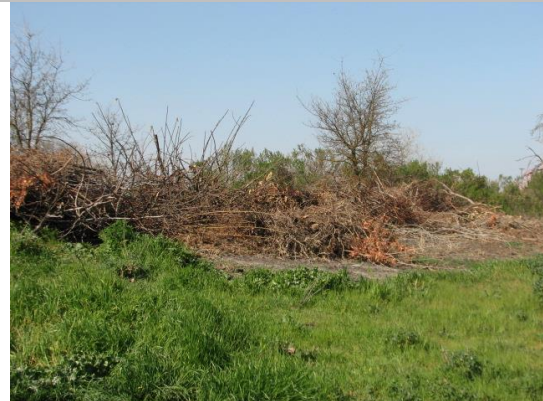
Photo 1 of 3 : FA\_2015\_NA0021\_351\_4\_20150914\_00004.jpg

LM Start	0.26	Rating **	M	Issue No.	4
LM End	0.26	Issue Type +	En	Location *	WS
Category	Earthen Levee			GPS Latitude/Longitude	
				Start	End
Item	Encroachments			38.722418 °	38.722418 °
				-121.806999 °	-121.806999 °
DWR ID	DWR_NA0021_01_s_2012_4				
Action/Comments					
Prunings

A continuous brush pile on levee. Spring 2013

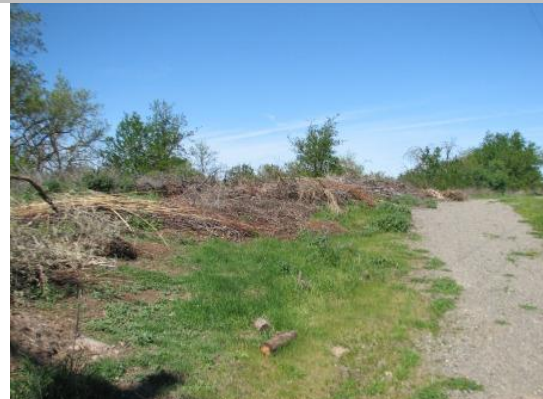
Photo 2 of 3 : FA\_2015\_NA0021\_351\_4\_20150914\_00005.jpg

The brush pile did not get burned this last winter. Spring 2014

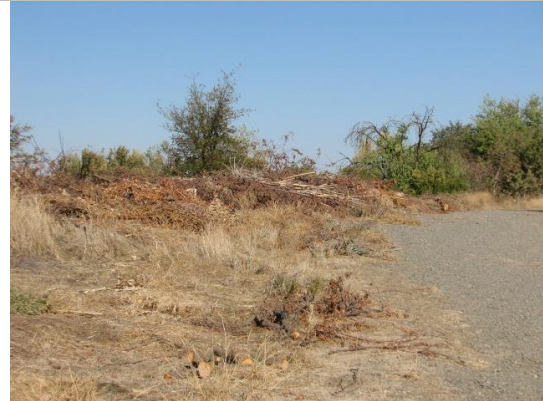
Photo 3 of 3 : FA\_2015\_NA0021\_351\_4\_20150914\_00006.jpg

The latest look of the ongoing brush pile. Fall 2013

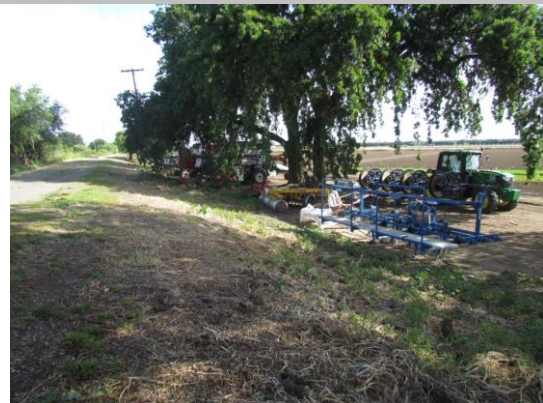
Photo 1 of 1 : FA\_2015\_NA0021\_351\_18\_20150914\_00018.jpg

LM Start	0.26	Rating **	M	Issue No.	18
LM End	0.26	Issue Type +	En	Location *	LS
Category	Earthen Levee			GPS Latitude/Longitude	
				Start	End
Item	Encroachments			38.722424 °	38.722424 °
				-121.806977 °	-121.806977 °
DWR ID	DWR_NA0021_01_s_2015_18				
Action/Comments					
Equipment

View of equipments on the landward side of the levee looking downstream. Spring 2015.

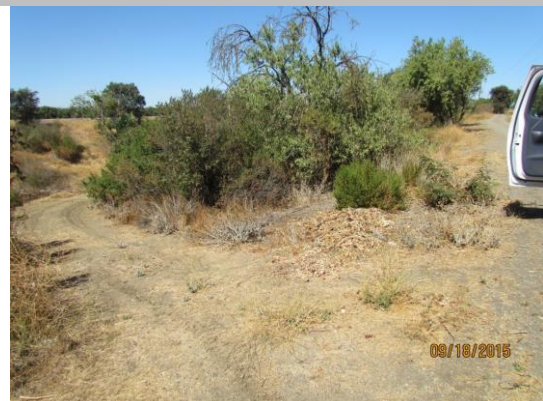
Photo 1 of 3 : FA\_2015\_NA0021\_351\_22\_20150921\_00026.jpg

LM Start	0.27	Rating **	M	Issue No.	22
LM End	0.27	Issue Type +	Ma	Location *	WS
Category	Earthen Levee			GPS Latitude/Longitude	
				Start	End
Item	Slope Stability			38.722620 °	38.722620 °
				-121.806958 °	-121.806958 °
DWR ID	DWR_NA0021_01_f_2015_22				
Action/Comments					
Repair the levee slope damaged by vehicle traffic and prevent access where possible.					
Inspector Comments: A vehicle ramp seems to have been made.

Perspective view of the trail on the waterward side of the levee looking downstream. Fall 2015.

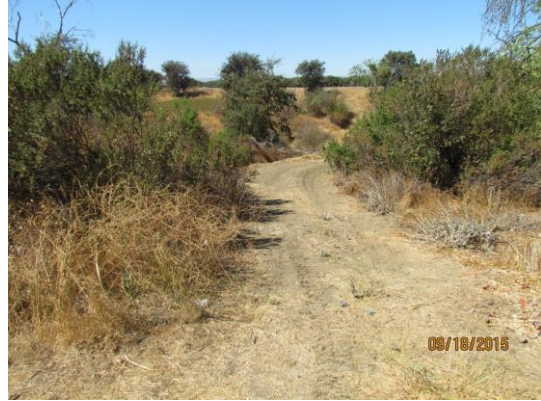
Photo 2 of 3 : FA\_2015\_NA0021\_351\_22\_20150921\_00025.jpg

View of the trail on the waterward side of the levee. Fall 2015.

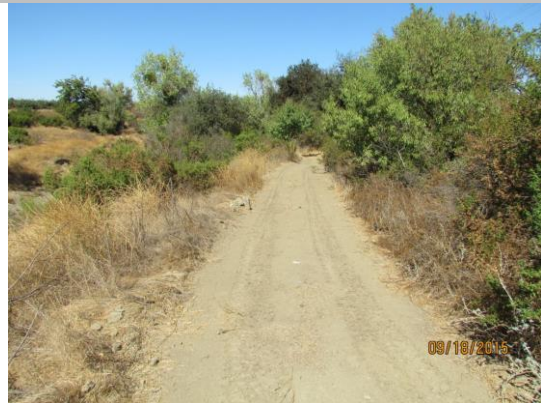
Photo 3 of 3 : FA\_2015\_NA0021\_351\_22\_20150921\_00031.jpg

The trail seems to be an access point that leads down to Cache Creek.  
Fall 2015.

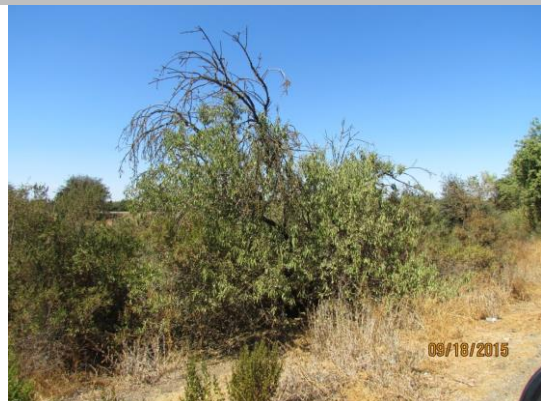
Photo 1 of 1 : FA\_2015\_NA0021\_351\_14\_20150921\_00024.jpg

LM Start	0.27	Rating **	A/W	Issue No.	14
LM End	0.27	Issue Type +	Ma	Location *	WS
Category	Earthen Levee			GPS Latitude/Longitude	
				Start	End
Item	Vegetation			38.722633 °	38.722633 °
				-121.806938 °	-121.806938 °
DWR ID	DWR_NA0021_01_s_2012_14				
Action/Comments					
Elderberries are blocking visibility and flood fight capability.

View of the elderberry on the waterward side of the levee looking downstream. Fall 2015.

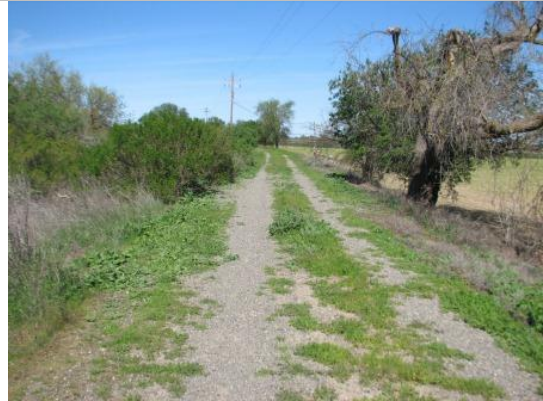
Photo 1 of 1 : FA\_2015\_NA0021\_351\_13\_20150914\_00012.jpg

LM Start	0.30	Rating **	M	Issue No.	13
LM End	0.50	Issue Type +	Ma	Location *	CR
Category	Earthen Levee			GPS Latitude/Longitude	
				Start	End
Item	Vegetation			38.723017 °	38.725844 °
				-121.806879 °	-121.806516 °
DWR ID	DWR_NA0021_01_s _ 2014_13				
Action/Comments					
Keep the crown roadway free of vegetation.

Vegetation on the crown needs to be controlled. Spring 2014

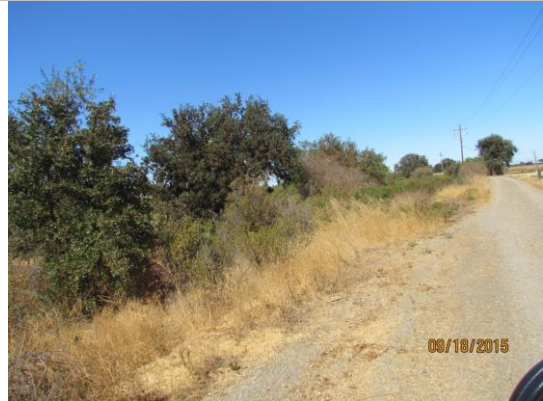
Photo 1 of 1 : FA\_2015\_NA0021\_351\_17\_20150921\_00023.jpg

LM Start	0.30	Rating **	U	Issue No.	17
LM End	0.50	Issue Type +	Ma	Location *	WS
Category	Earthen Levee			GPS Latitude/Longitude	
				Start	End
Item	Vegetation			38.723041 °	38.725887 °
				-121.806877 °	-121.806550 °
DWR ID	DWR_NA0021_01_s _ 2012_17				
Action/Comments					
Remove the wild growth other than native grasses from the levee slopes.

View of the vegetation on the waterward side of the levee looking downstream. Fall 2015.

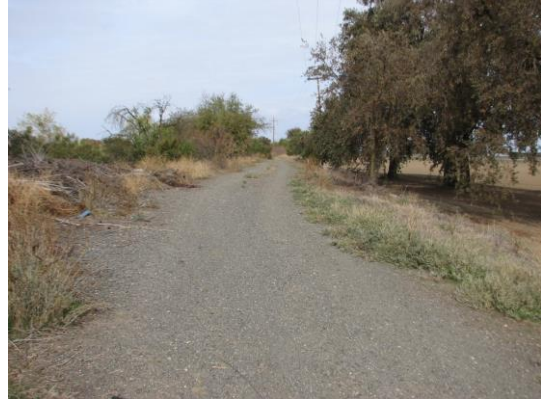
Photo 1 of 3 : FA\_2015\_NA0021\_351\_1\_20150914\_00001.jpg

LM Start	0.33	Rating **	M	Issue No.	1
LM End	0.50	Issue Type +	Ma	Location *	LS
Category	Earthen Levee			GPS Latitude/Longitude	
				Start	End
Item	Vegetation			38.723381 °	38.725835 °
				-121.806786 °	-121.806526 °
DWR ID	DWR_NA0021_01_s _ 2015_1				
Action/Comments					
Remove the wild growth other than native grasses from the levee slopes. Inspector Comments: This area now has been declared a habitat restoration area by the Cache Creek Conservancy.

Vegetation on levee slopes and crown. Fall 2014.

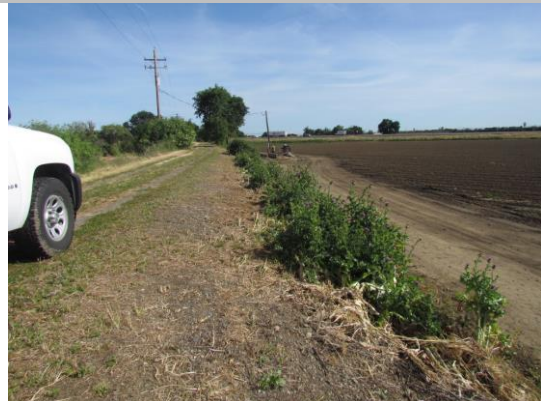
Photo 2 of 3 : FA\_2015\_NA0021\_351\_1\_20150914\_00002.jpg

View of vegetation on the landward side of the levee looking downstream. Spring 2015.

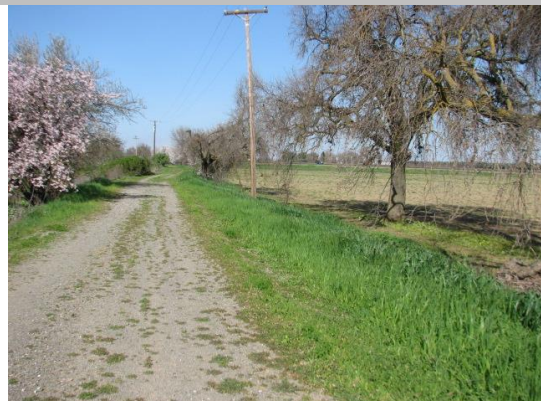
Photo 3 of 3 : FA\_2015\_NA0021\_351\_1\_20150914\_00003.jpg

Vegetation needs to be mowed taller than 12". Spring 2013

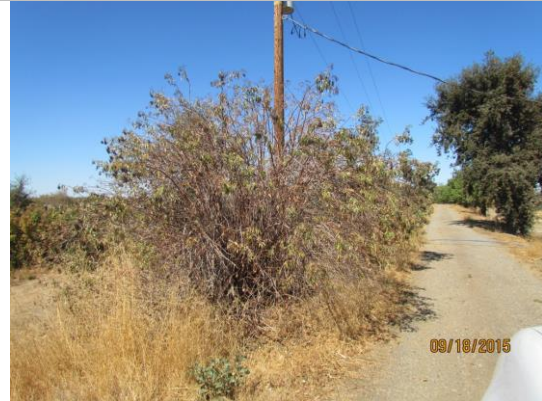
Photo 1 of 1 : FA\_2015\_NA0021\_351\_20\_20150921\_00027.jpg

LM Start	0.36	Rating **	M	Issue No.	20
LM End	0.36	Issue Type +	Ma	Location *	LS
Category	Earthen Levee			GPS Latitude/Longitude	
				Start	End
Item	Vegetation			38.723802 °	38.723802 °
				-121.806700 °	-121.806700 °
DWR ID	DWR_NA0021_01_s _ 2015_20				
Action/Comments					
Elderberries are blocking visibility and flood fight capability.

View of the elderberry on the waterward side of the levee looking downstream. Fall 2015.

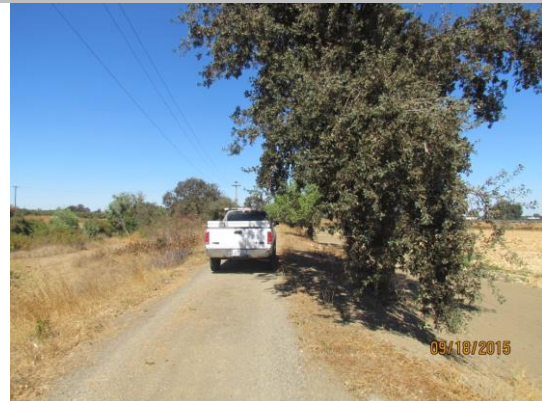
Photo 1 of 1 : FA\_2015\_NA0021\_351\_6\_20150921\_00028.jpg

LM Start	0.36	Rating **	M	Issue No.	6
LM End	0.36	Issue Type +	Ma	Location *	LS
Category	Earthen Levee			GPS Latitude/Longitude	
				Start	End
Item	Trim / Thin Trees			38.723903 °	38.723903 °
				-121.806613 °	-121.806613 °
DWR ID	DWR_NA0021_01_s _ 2012_6				
Action/Comments					
Trim trees to at least five feet above ground level.

View of the tree on the landward side of the levee looking downstream. Fall 2015.

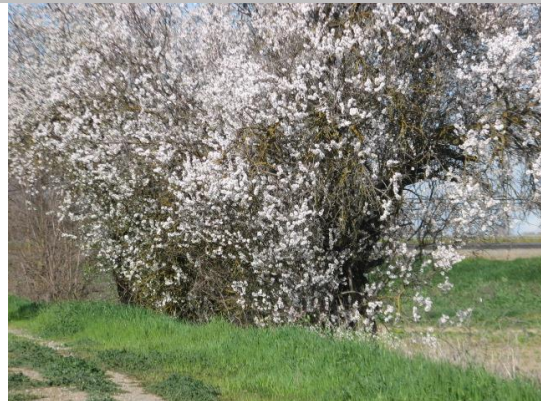
Photo 1 of 2 : FA\_2015\_NA0021\_351\_9\_20150914\_00010.jpg

LM Start	0.44	Rating **	M	Issue No.	9
LM End	0.44	Issue Type +	Ma	Location *	LS
Category	Earthen Levee			GPS Latitude/Longitude	
				Start	End
Item	Trim / Thin Trees			38.725022 °	38.725022 °
				-121.806478 °	-121.806478 °
DWR ID	DWR_NA0021_01_s_2012_9				
Action/Comments					
Trim trees to at least five feet above ground level.

Trees need to be trimmed to 5'. Spring 2013

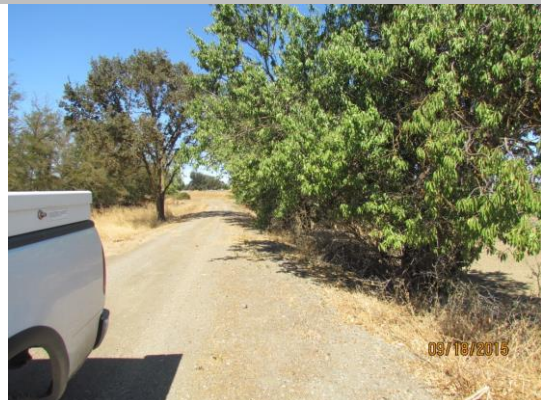
Photo 2 of 2 : FA\_2015\_NA0021\_351\_9\_20150921\_00030.jpg

View of the tree that needs to be trimmed on the landward side of the levee looking downstream. Fall 2015.

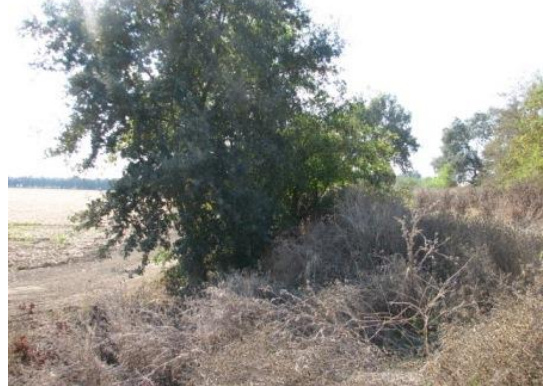
Photo 1 of 2 : FA\_2015\_NA0021\_351\_10\_20150914\_00011.jpg

LM Start	0.47	Rating **	M	Issue No.	10
LM End	0.47	Issue Type +	Ma	Location *	LS
Category	Earthen Levee			GPS Latitude/Longitude	
				Start	End
Item	Trim / Thin Trees			38.725427 °	38.725427 °
				-121.806470 °	-121.806470 °
DWR ID	DWR_NA0021_01_s _ 2012_10				
Action/Comments					
Trim trees to at least five feet above ground level.

The tree needs to be trimmed up. Photo taken fall of 2011.

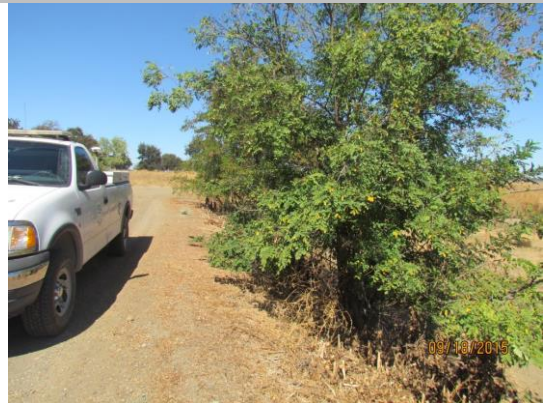
Photo 2 of 2 : FA\_2015\_NA0021\_351\_10\_20150921\_00029.jpg

View of the tree on the landward side of the levee looking downstream.  
Fall 2015.

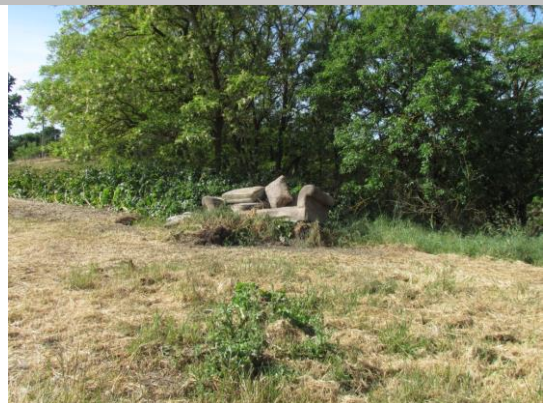
Photo 1 of 1 : FA\_2015\_NA0021\_351\_21\_20150914\_00020.jpg

LM Start	0.49	Rating **	M	Issue No.	21
LM End	0.49	Issue Type +	En	Location *	WS
Category	Earthen Levee			GPS Latitude/Longitude	
				Start	End
Item	Encroachments			38.725692 °	38.725692 °
				-121.806590 °	-121.806590 °
DWR ID	DWR_NA0021_01_s _ 2015_21				
Action/Comments					
Debris

View of a couch on the waterward side of the levee looking upstream.  
Spring 2015.
